PO Box 417,
Manchester Center, VT 05255
(802)558-2985

*Aquatic Invasive Weed Control
& Dredging Services*

AE Commercial Diving Services 2019 Lake George Eurasian Milfoil Management Report

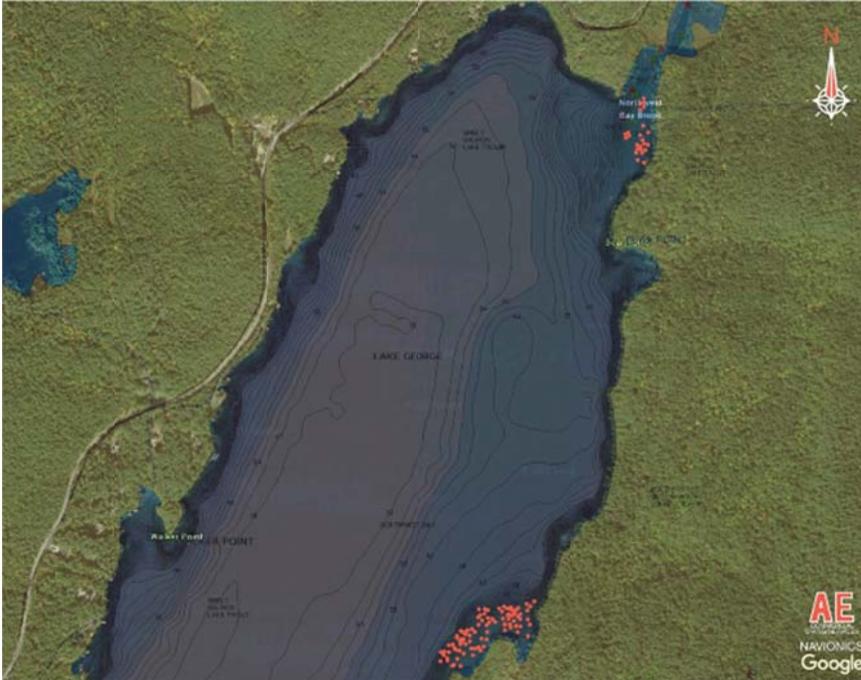
- **Northwest Bay (Sites #1 and 24): Total Pounds Harvested: 7,400**

This area was completely harvested in 2019. The areas worked furthest north in NWB, near the inlet, have had the best success. The bottom is much softer, comprised mostly of mud and native vegetation.

As you head down the east shoreline to the southern sectors of NWB the bottom composition becomes less optimal. The lake bottom becomes rockier and the soft sediment seems to shift to more of a clay base. This can cause poor visibility due to the nature of agitated clay in the water column. These southern sectors are comprised of dense beds located on large rock deposits. Therefore, the invasive plants are harder to eradicate due to the difficulty of digging roots from the rocky bottom.

It is imperative that we continue to remove the invasive plants in this site, however; it is important to recognize how the changes in bottom composition from the northern sector to the southern sector of this site affect productivity. The increase in pounds of invasive Eurasian Watermilfoil removed this year as compared to last year from this site is a clear indication that progress can be made with more time on site, as the days on site increased by five. It also suggests that many contextual factors must be considered when evaluating productivity. Site to site comparison is less informative than annual data from a site contrasted against that same site's past annual data.

Additionally, there are many fishermen who frequent these areas; continued efforts to educate fishermen on how they can help to reduce fragmentation is essential, as our observations of the southern sectors of this site demonstrate a 'moving' of the main beds south-ward, which is consistent with observed fishing patterns for boaters in the areas.

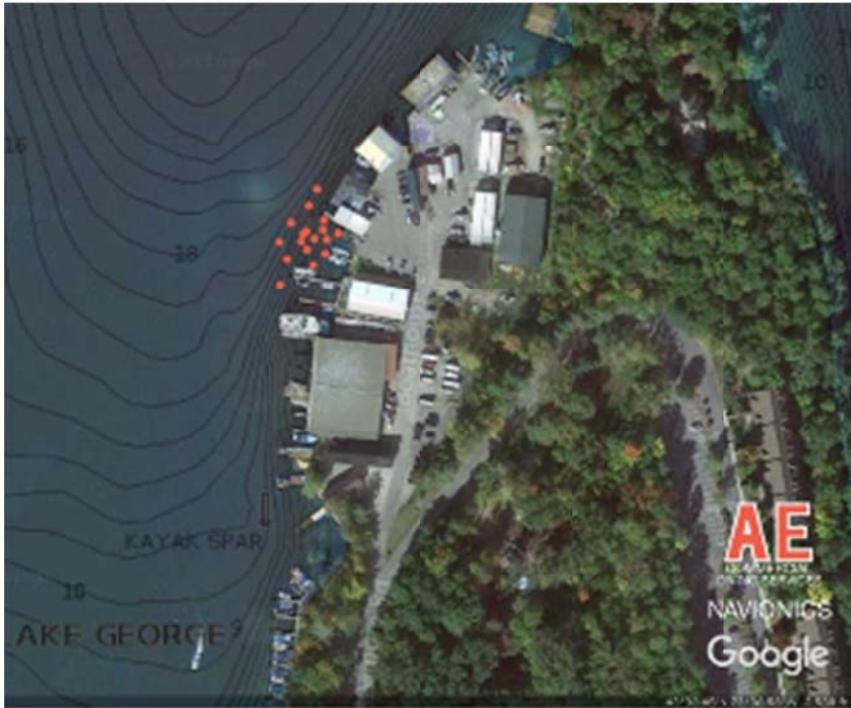
- **West Side of Green Island (Site #5): *Total Pounds Harvested: 570***

This area was completely harvested in 2019. The West Green Island site was completed quickly. The 2019 season was the first time AED harvested the area and we only found sporadic growth with a couple small clusters of medium sized plants.

This area should be monitored due to a new patch discovered in the channel, however, we believe it will continue to prove to be one of the less-challenging sites in 2020.

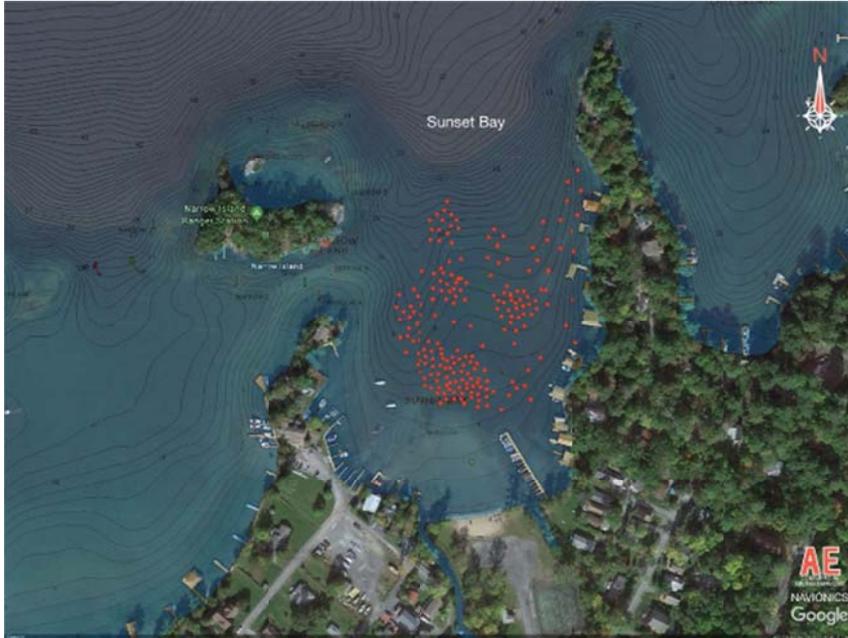
- **Sunset Bay (Site #6): Total Pounds Harvested: 18,375**

This area was completely harvested in 2019. Two harvesters and an occasional hand pulling crew worked in Sunset Bay in the 2019 season. We put a good deal of time and effort into the bay in 2018 and made a good deal of progress. We increased our efforts in 2019, which pushed progress along. The bottom composition is ideal for the removal of root systems and there is an abundance of native vegetation that can, (and often will), take over once invasive Eurasian Watermilfoil is removed. Because of these conditions, we expected to see additional progress in the 2020 season.

There is a good chance that there is a dense bed of Eurasian Watermilfoil located north of Sunset Bay that is seeding further infestation. We recommend a survey of the area early in the season to determine if this is indeed contributing to the sparse to moderate growth we observed in roughly 50% of the bay.

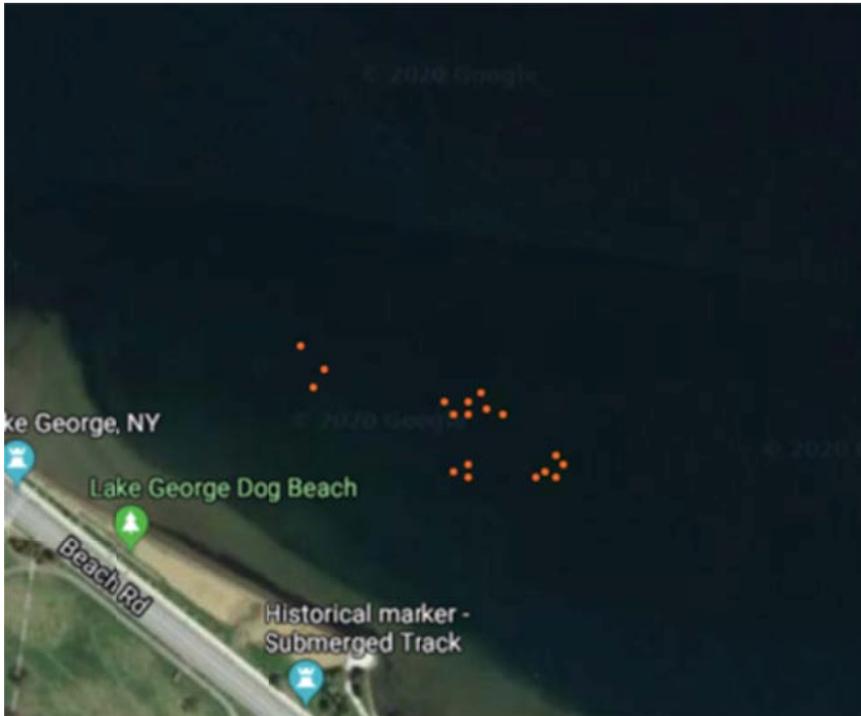
- **Dog Beach (Site #8): *Total Pounds Harvested: 150***

This area was not completed in 2019. This site proved to be a very challenging area to perform DASH at. The bottom composition was mostly loose sediment on a steep grade, which made it difficult to anchor properly at the site. Wind was also a factor in keeping anchored. While visibility was good most of the time, it was very difficult for crews to work into the good visibility due to the above-mentioned anchoring issues.

This site will continue to prove challenging to work but is an essential area of infestation to work away at given its location in a high traffic area. Further discussion is required to determine how to proceed with this site.

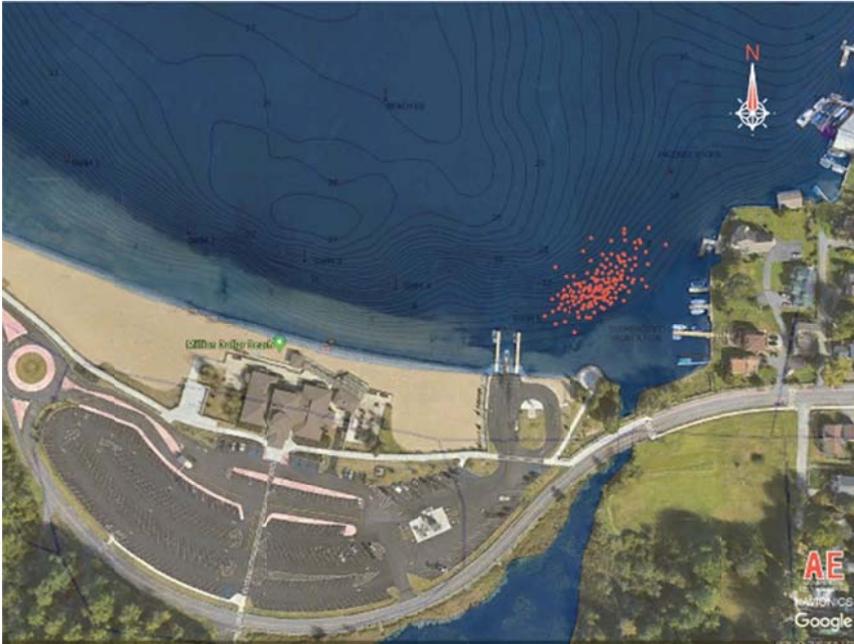
- **Million Dollar Beach/Boat Launch (Site #10): Total Pounds Harvested: 6,135**

This area was completely harvested in 2019. The boat launch at Million Dollar Beach harbored a large dense patch of Eurasian Watermilfoil. The patch began due east of the launch and extended northward up the shore. The bottom composition at this site was ideal for harvesting, consisting of a soft sediment. Because of the almost complete removal of the Eurasian Watermilfoil, (seeds and roots may be still present in the bottom), we expect that the site to be greatly improved for the beginning of the 2020 boating season. However, due to the nature of it being a boat launch where sediment is stirred by launching vessels, vessels possibly bringing Eurasian Milfoil back from other parts of the lake to the site when preparing to exit, and strong winds naturally pushing any fragmentation towards that corner of the lake, we fully anticipate a flare up of infestation after the season has begun.

We recommend a survey of this area early in the season to remove any regrowth prior to the heavier traffic days that come with warmer weather. We also recommend periodic surveys throughout the season to detect any growth for the reasons given in the summary.

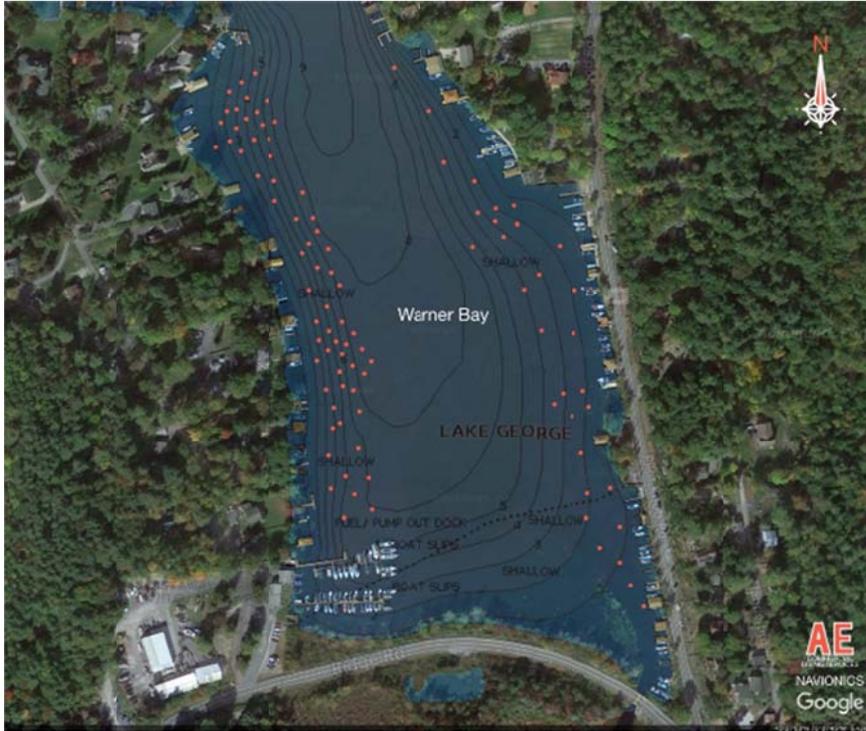
- **Warner Bay (Site #11): Total Pounds Harvested: 4,530**

This area was completely harvested in 2019. Warner Bay has sporadic growth down both the east and west shorelines. The middle of the bay, when surveyed, appeared to be free of Eurasian Watermilfoil, as it has in past years. We visited Warner Bay throughout the summer with a hand pulling crew, and a harvester was brought in to help remove areas that would have been too time consuming for hand pulling crews a couple of times. The inlet into Warner Bay creates a low visibility situation for the dive crews.

While sporadic growth can often be best addressed through hand pulling, the large, spread-out nature of the bay, coupled with visibility concerns and boat traffic, have led us to believe that suction harvesting would be a more effective control method for this site. We recommend this change be implemented in 2020.

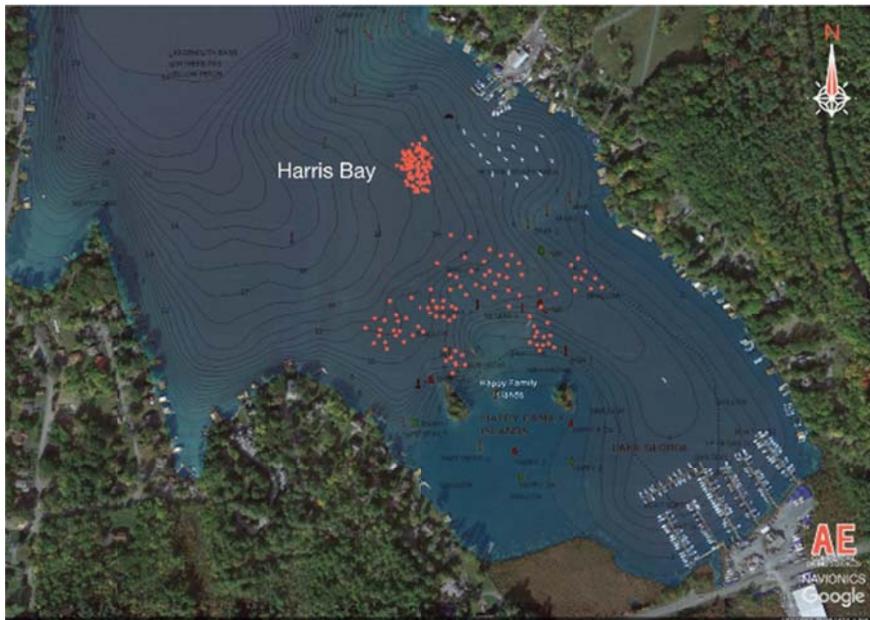
- **Harris Bay/ Site #14: Total Pounds Harvested: 4,665**

This area was completely harvested in 2019. Harris Bay has proven to be a tricky site to the wide variety of bottom composition, topography, and sediment. The area surrounding the islands consists of boulders and rocks, making it difficult to remove plants *and* their entire root systems. As a result, the risk for regrowth is high, and will require monitoring.

As you move away from the islands, some sectors of Harris Bay shift dramatically to soft sediment with clusters of native vegetation. These areas are showing the most improvement and are more easily controlled.

Farther still from the islands, however, large flat sectors open-up with a depth ideal for invasive Eurasian Watermilfoil to proliferate. These open ‘plane-like’ sections make conditions ideal for the invasive plants to take over quickly in large, dense beds if left unchecked.

Progress is being made but at a much slower pace than was hoped. Areas worked in 2018 remained open in 2019 but new spots continue to pop up due to the conditions described above. Despite this, work was completed.

Harris Bay is complex and requires vigilance. Ongoing discussion regarding the site is recommended to ensure progress is not undone.

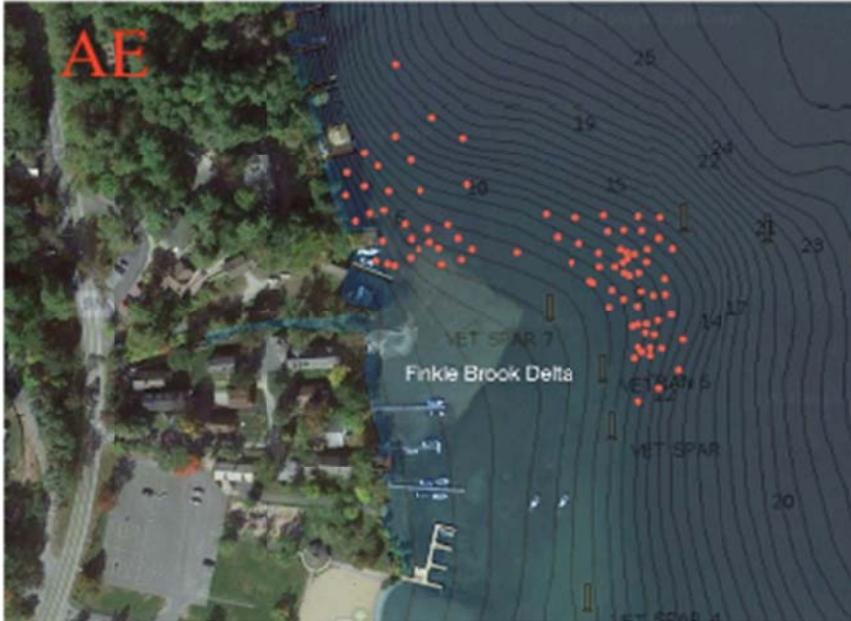
- **Finkle Brook Delta (Site #15): *Total Pounds Harvested: 1,555***

This area was completely harvested in 2019. The Finkle Brook Site is broken into two distinct sectors: the delta and the offshore sector adjacent to the beach park. Work completed in the delta in 2018 has proven to have a positive effect on the reduction of invasive Eurasian Watermilfoil. Very little regrowth was found near the inlet of Finkle Brook or the immediate area of the delta in 2019.

The offshore sector had slightly more new growth than the inlet, but still showed a reduction due to work completed in 2018.

We believe growth in the offshore sector of Finkle Brook may be related to regrowth in part. However, a patch discovered a few hundred meters southeast is suspected to be contributing to regrowth in the area due to fragmentation. We recommend a survey in the spring in order to determine harvesting needs as well as if removal of the aforementioned patch has reduced regrowth or not.

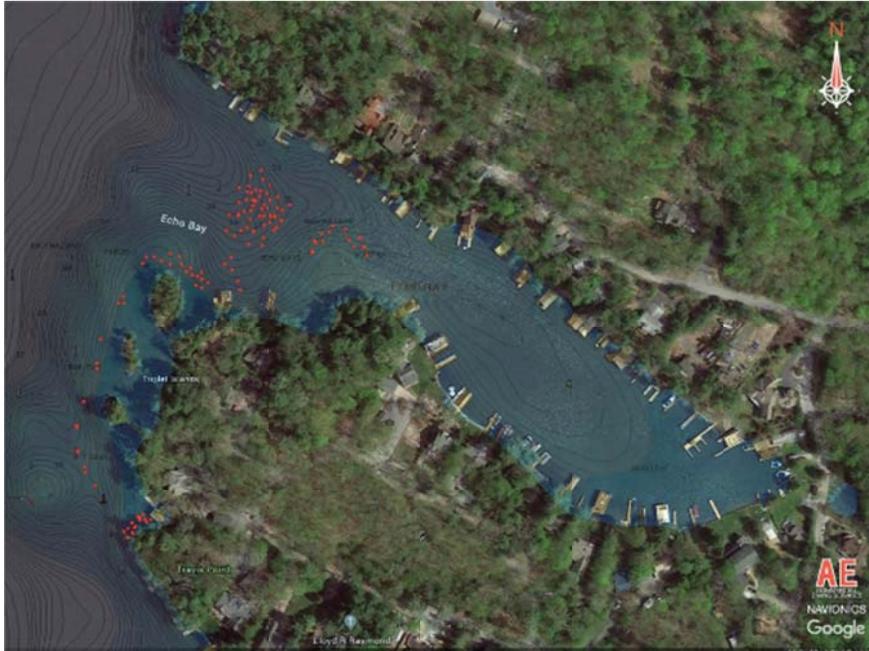
- **Echo Bay (Site #17): Total Pounds Harvested: 750**

This area was completely harvested in 2019. Usually combined with Elizabeth Island, this site was separated out this year due to its contextual challenges. The site was moderate infested with Eurasian Watermilfoil at the mouth of the bay that spread southward around the point and islands. This created challenges for our crews to anchor, dive, and transit safely given the high boat traffic in an out of work zone. Transiting and working around the point southward was also hazardous for these reasons. The bottom composition was also challenging; a rocky bottom layered upon with mud made it challenging to remove the root balls of the Eurasian Watermilfoil. A steady current around the point and islands stirred up the mud and made visibility tricky.

Going forward, it will also be important for geography of the site to be recognized as a formidable challenge for the safety and productivity of our crews; even the safest boaters following the strictest guidelines for diver safety create a potential danger to crews because of the small mouth of the bay and depth. Further discussion is recommended regarding these concerns.

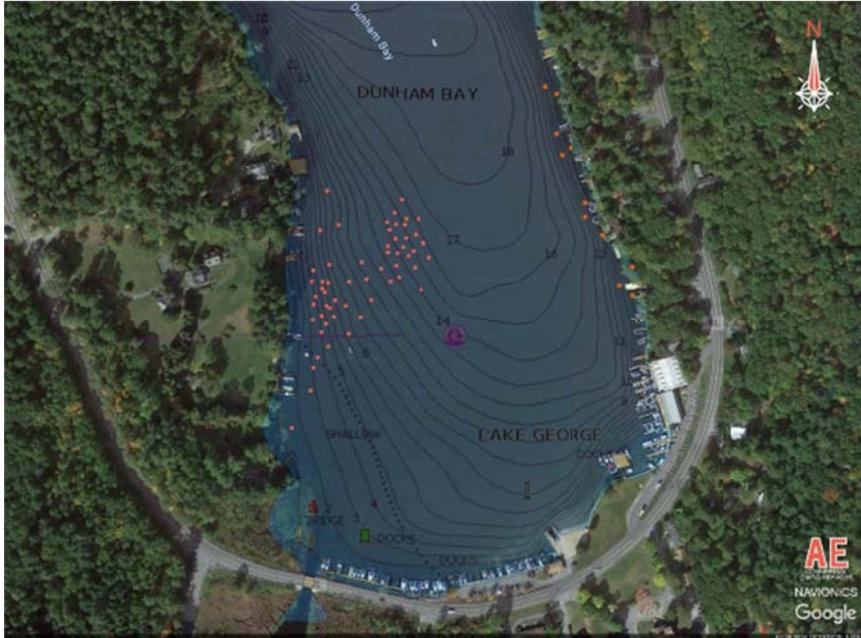
- **Dunham's Bay (Site #19): Total Pounds Harvested: 3,765**

This area was completely harvested in 2019. Overall, Dunham's Bay looked very good. There was a sporadic vein of milfoil along roughly 60% of the eastern shore. The western shore revealed very little growth of Eurasian Watermilfoil, with only a few plants along its entirety. The bulk of harvesting efforts in Dunham's Bay was in the center of the bay in roughly 20 - 25 feet of water. The bed was small but dense. It was located at an old bottom barrier site.

In the coming season, it will be very important to monitor Dunham's Bay, as there is a very busy marina on site. Though most of the dense growth was away from the marina, boat traffic could lead to fragmentation and spread of Eurasian Watermilfoil quickly. We recommend continued DASH as well as frequent surveys in order to keep Dunham's Bay on a trajectory towards optimum containment and control.

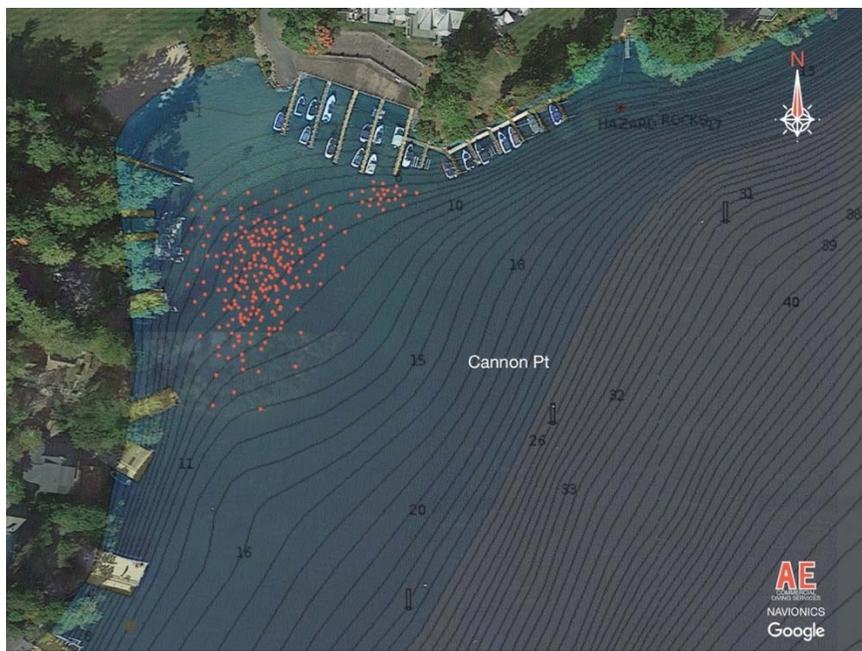
- **Cannon Point (Site #26): Total Pounds Harvested: 6,885**

This area was completely harvested in 2019. When we began work at Cannon Point in 2019, we found that it resembled how it had looked before commencing work in 2018: a dense bed of invasive Eurasian Watermilfoil was located southwest of the point, in roughly the same place as 2018, though the bed had shifted slightly to the east.

There are several contributing factors to why work in this area has only held the advancement of the Eurasian Watermilfoil at bay rather than reduce it. First, the lake bottom at this site is a dense sandy base that encourages deep root growth. Removing the entire root ball of the invasive Eurasian Watermilfoil plants that grows here is time consuming and difficult, though clearly imperative. Next, this site is thick with native plant life that is punctuated with Eurasian Watermilfoil. Removing the invasive plant without damage or destruction of these native plants is very difficult and leads to a situation where divers are sorting through stems at the bottom of the lake in poor visibility conditions. Finally, Cannon Point is rife with boat traffic and we suspect the perpetual traffic is leading to a rapid regrowth potential through fragmentation.

We recommend that this site received a continued strong effort in order to keep progress moving forward. It is crucial that the dense bed of Eurasian Watermilfoil be held in check to reduce movement of the bed into areas south of Cannon Point, as was observed occurring between 2018 and 2019, or beyond. The increase of days allotted to this site, (5 in 2018 to 13 in 2019), allowed for a more robust removal of invasive Eurasian Watermilfoil and must continue in order to control this site's infestation.

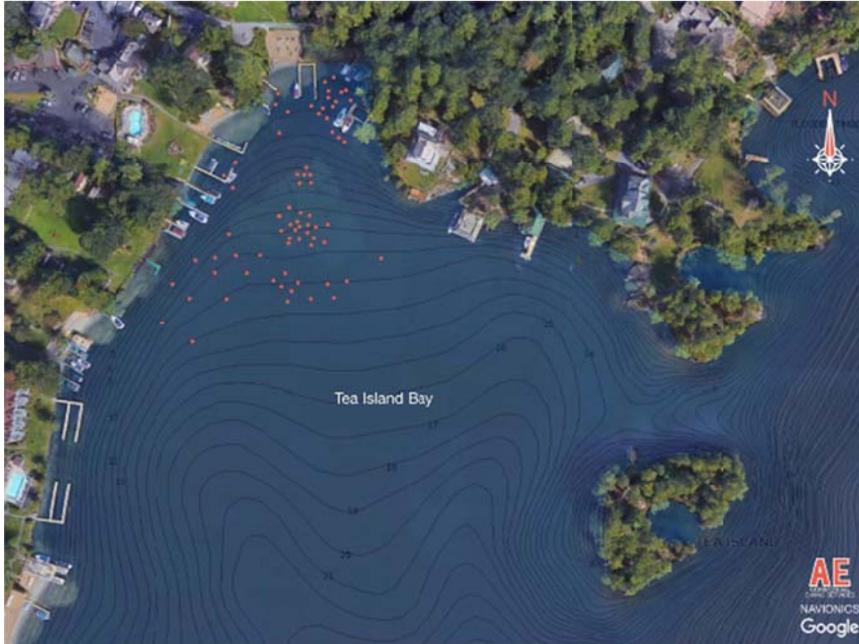
- **Tea Island Bay (Site #30): Total Pounds Harvested: 1,170**

This area was completely harvested in 2019. The initial survey prior to the commencement of work in 2019 revealed that work in 2018 on the Tea Island site was successful in significantly reducing the infestation of Eurasian Watermilfoil. This made for quick work at the site. However, the shallow areas of the site, especially in the areas around the resorts and their docks, revealed new growth that was more complicated to remove.

New growth at this site, (most likely due to fragmentation caused by a high tempo of boat traffic), is in areas where DASH work is much harder to conduct, such as under and around docks and moorings. We recommend that close attention be paid to the trend of regrowth at this site in order to prevent a relapse into a denser area of infestation, especially in shallow areas.

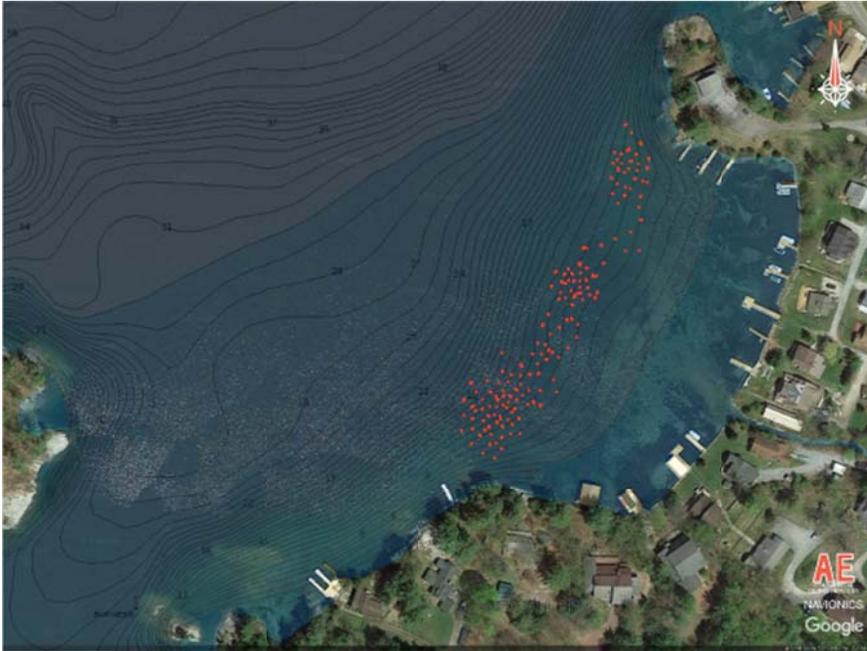
- **Eichlerville Bay (Site #51): Total Pounds Harvested: 4,970**

This area was completely harvest in 2019. Eichlerville Bay revealed two dense beds of Eurasian Watermilfoil connected by a smaller line of moderate growth. Two DASH crews worked the large patches towards each other and through to each other in the areas of moderate growth. Harvesting was completed in this area; however, the varied bottom composition causes concerns to potential regrowth. Because the site was done late in the season, it was not possible to check for regrowth after harvesting in 2019. A rocky bottom composition layered with mud on top, Eichlerville Bay was a complex site to remove invasive Eurasian Watermilfoil from, with a great deal of uncertainty if complete root removal was accomplished.

Because this site was completed at the end of the DASH season in 2019, we recommend that it be revisited earlier in the 2020 season in order to check regrowth and eliminate the potential for fragmentation into other areas, (which is possible in this high traffic site).

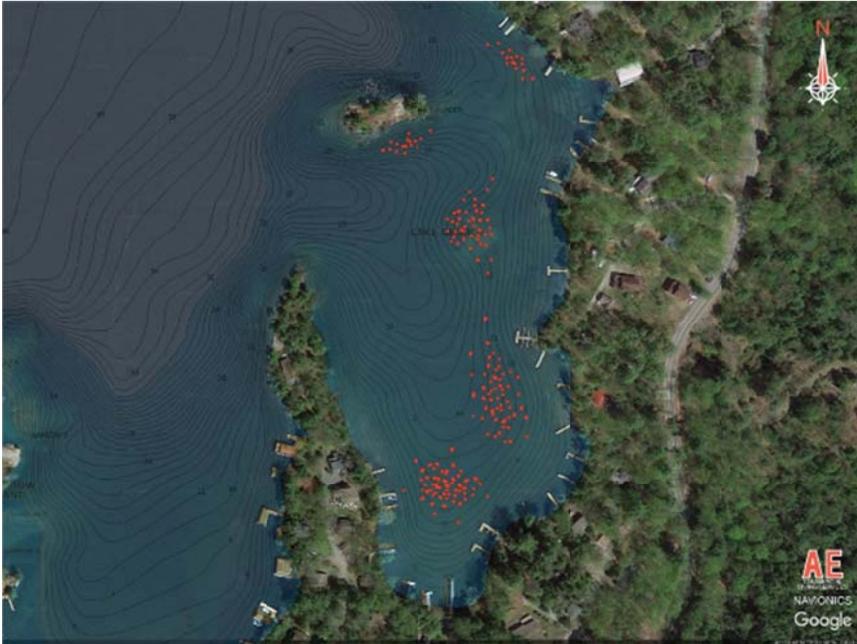
- **Indian Bay (Site #55): Total Pounds Harvested: 6,570**

This area was not completed in 2019. Indian Bay contained several isolated dense beds of Eurasian Watermilfoil, with sporadic growth throughout the shallows. The sandy bottom composition made harvesting easier for the two DASH crews and the hand pulling team. However, this site was worked last in the season and was not completely harvested before the season ended.

We recommend that Indian Bay be revisited earlier in the 2020 season in order to eliminate the potential for fragmentation out of *and* inside of this site that is probable due to the high-traffic nature of the bay.

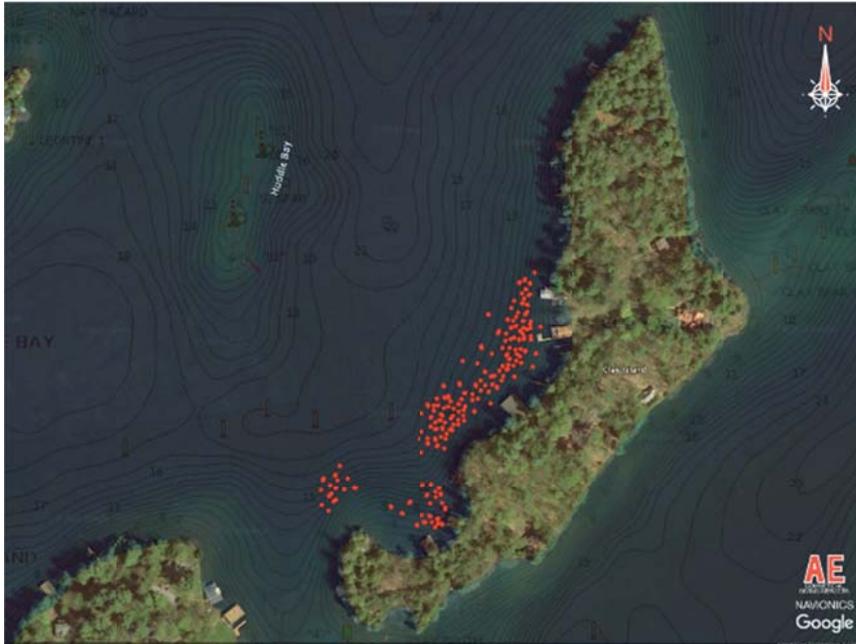
- **Clay Island (Site #97): Total Pounds Harvested: 13,205**

This area was completely harvested in 2019. The Clay Island site consisted of a large dense bed on the western shore of Clay Island. The site was worked with two harvesters and occasionally a hand pulling crew. The harvesters started on opposite ends of the dense bed and worked to reach each other in the center. After completion, the site seemed to hold for the remainder of the summer. However, the bottom composition consisted of sand and clay. This makes eradicating root systems more troublesome.

This site should be revisited earlier in 2020 to survey potential regrowth and ensure its removal as quickly as possible. The clay/sand bottom composition will continue to make this site a priority each year.

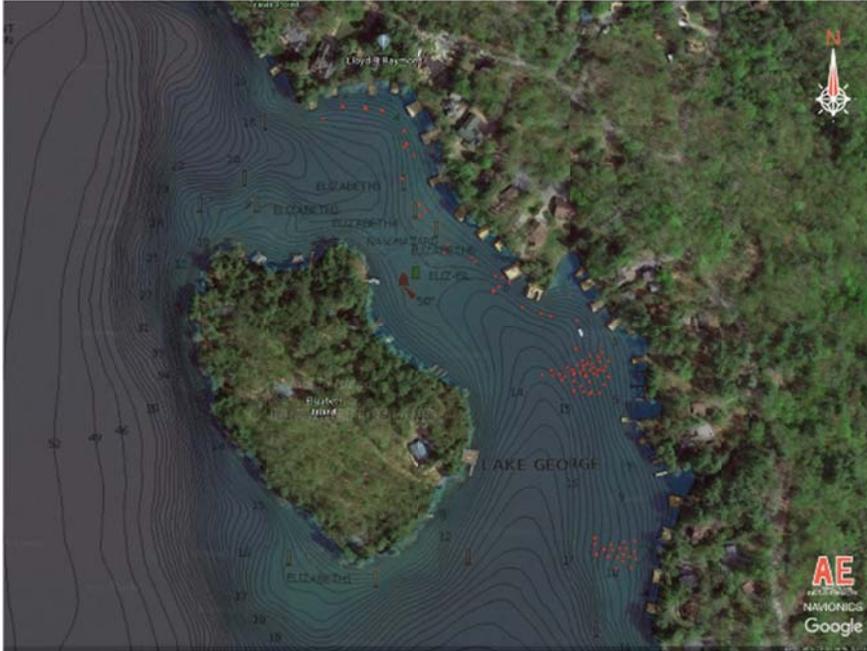
- **Elizabeth Island (Site #107): *Total Pounds Harvested: 750***

This area was completely harvested in 2019. The Elizabeth Island site, (new to us in 2019), was completed faster than anticipated. There were only a few small dense beds in areas of shallow water, and the crews had no problem finding them and removing them.

Though the work was fast and straightforward at this site, the dense beds were located on rocky deposits which make for a difficult removal of the Eurasian Milfoil root ball. In addition to continued DASH work, we recommend a site survey of the area in 2020 to ensure the beds have not moved or become larger.

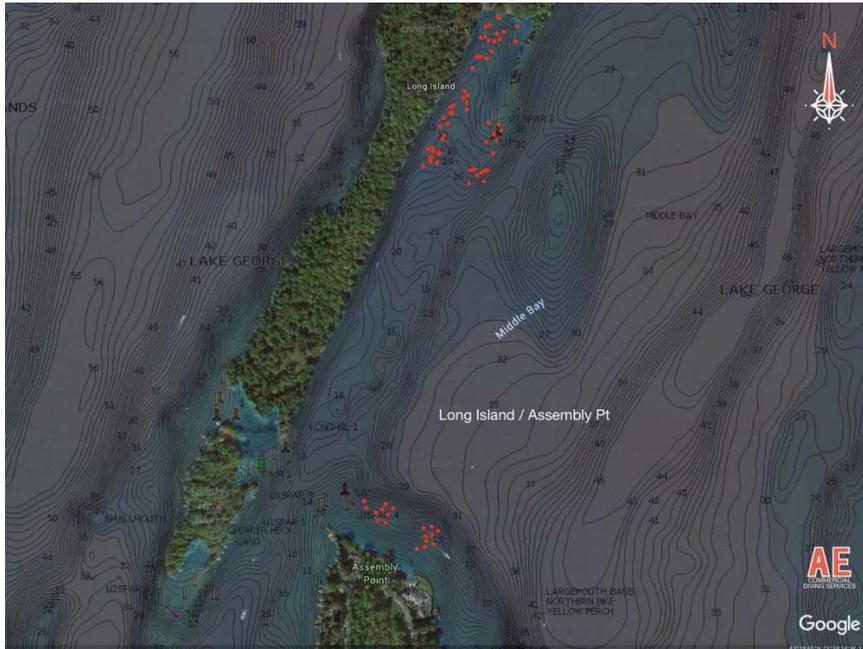
- **Long Island/Assembly Point (Site #202): Total Pounds Harvested: 1,515**

This area was completely harvested in 2019. The Long Island site looked to be greatly improved as compared to when it was initially observed, (prior to DASH in 2018). Due to the rocky bottom composition, we expected to find regrowth, but were happy to see a serious decline. The northern and southern sectors each prove to have their own challenges, but overall, the site work here was done more easily than expected.

We recommend that a hand pulling crew continue to monitor the site throughout the season for any potential DASH needs that may arise.

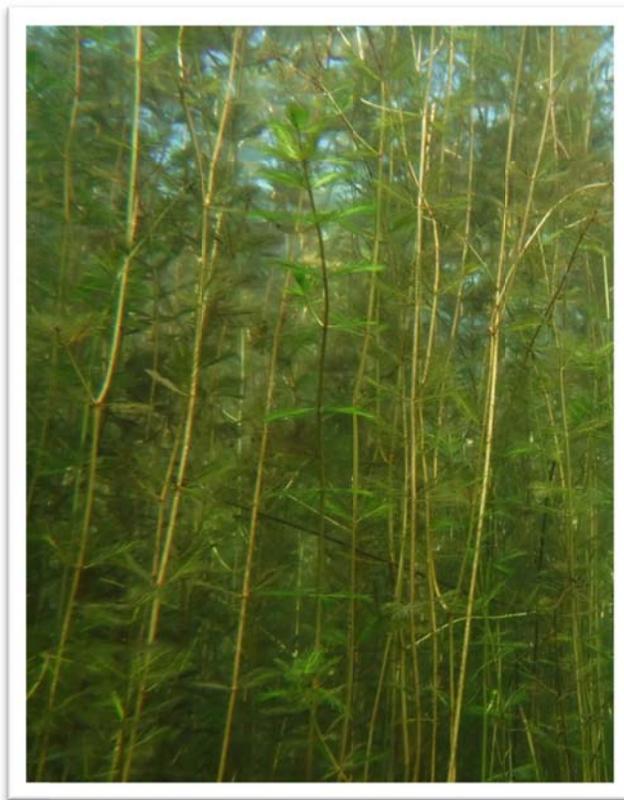
2. Eurasian Watermilfoil Dense Growth
(Northwest Bay, June 2019)
© 2019 AECDS All rights reserved.

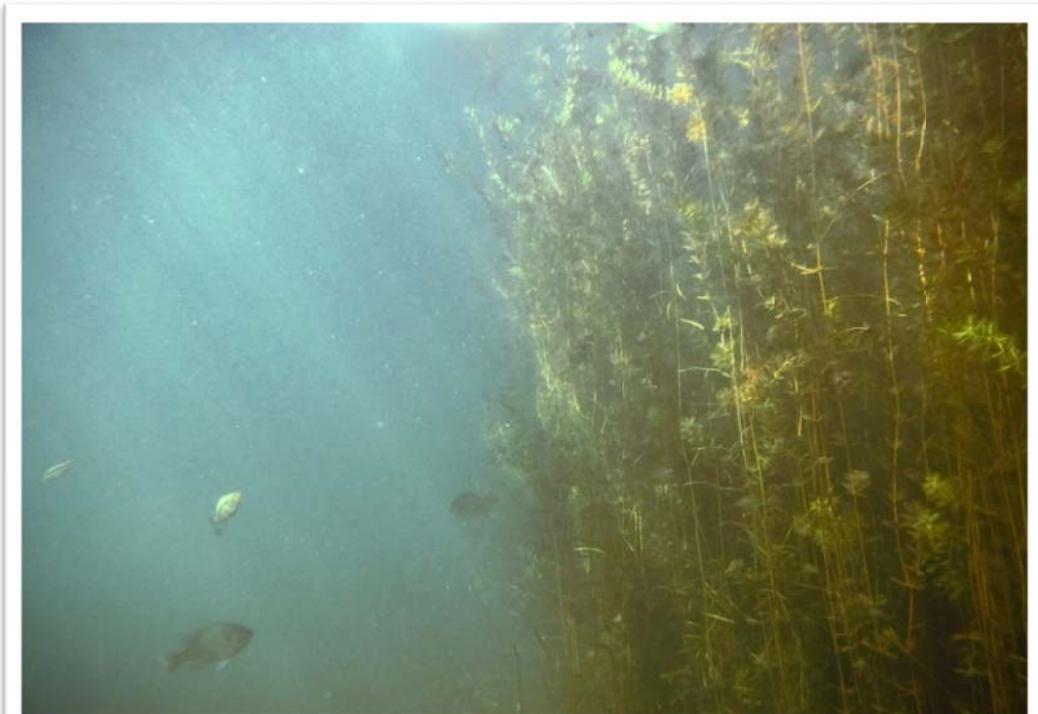
4. Eurasian Watermilfoil ‘Wall’

(On the left is an area cleared by divers the day before in Northwest Bay, June 2019. The right side shows the density and height of the plants. Very little to no native plant life was observed in this dense patch.)

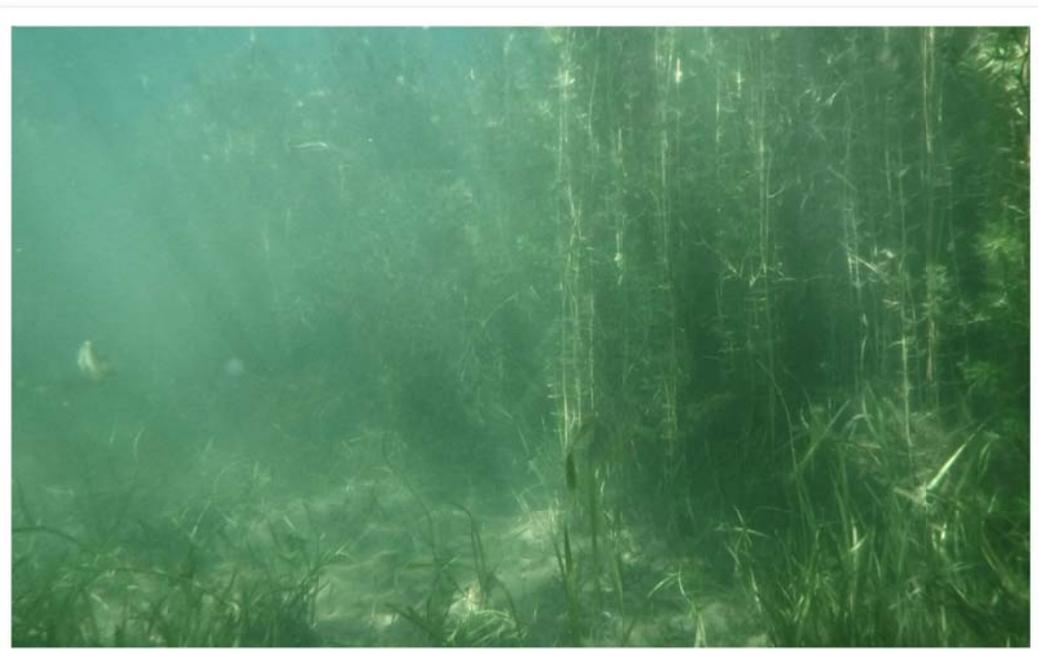
5. Eurasian Watermilfoil Behind Harvested Area

(Careful harvesting by AECDS Divers ensures native plant life is retained and able to reclaim the area.) © 2019 AECDS All rights reserved.
