**LAKE GEORGE
MILFOIL PROJECT**

ANNUAL REPORT 2020

PREPARED BY:
AE COMMERCIAL
DIVING SERVICES, INC.

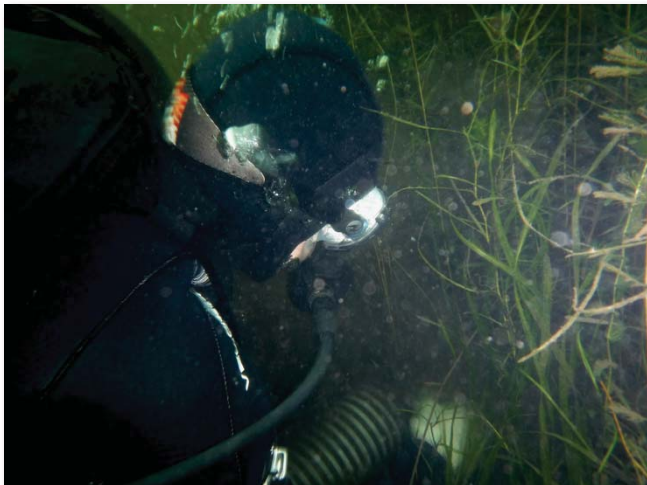
Figure 2: A diver guides uprooted Eurasian Watermilfoil into the suction hose so that it may be delivered to the boat on the surface. (Photo by HK Sotak, Copyright 2021.)

Diver Assisted Suction Harvesting, (hereby referred to as DASH), is the process by which SCUBA divers guide a suction hose to the area of the targeted species within a body of water and, after carefully removing the roots from the substrate, deliver the stems and root ball to the suction hose. The entire plant then travels up the length of the hose to boat on the surface where it is deposited on a table and sorted by a boat tender for disposal. DASH is an effective method to reduce and control large beds of Eurasian Milfoil expediently so as to prevent it from spreading through fragmentation or seeding. AE Commercial Diving Services has developed a patent pending sorting system that allows the nutrient rich substrate to return to the bottom where it is needed to support regrowth and health of

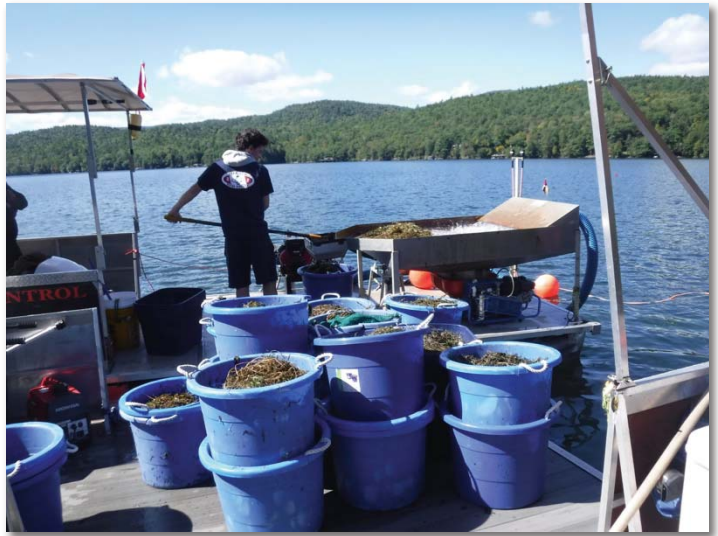
ABOVE: A crew member from AECDS removing Eurasian Watermilfoil plants from the sorting table and disposing them into tubs to be taken to trailer disposal sites. Photo by HK Sotak, Copyright AECDS 2021

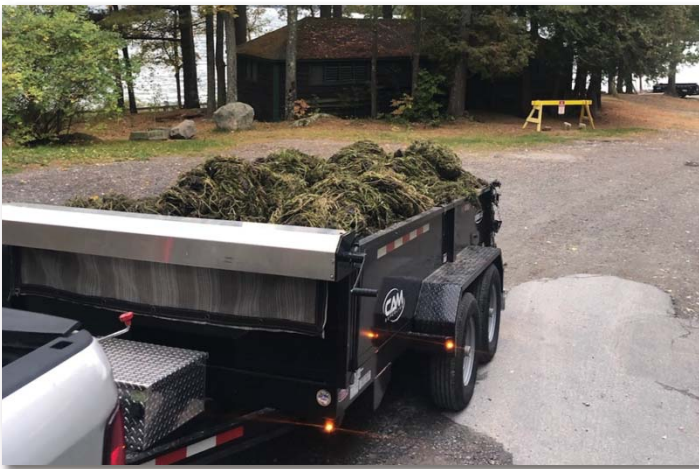
LEFT: Lake George Park Commission trailer used for Eurasian Watermilfoil biomass disposal. Picture courtesy of Dave Wick, Executive Director, Lake George Park Commission.

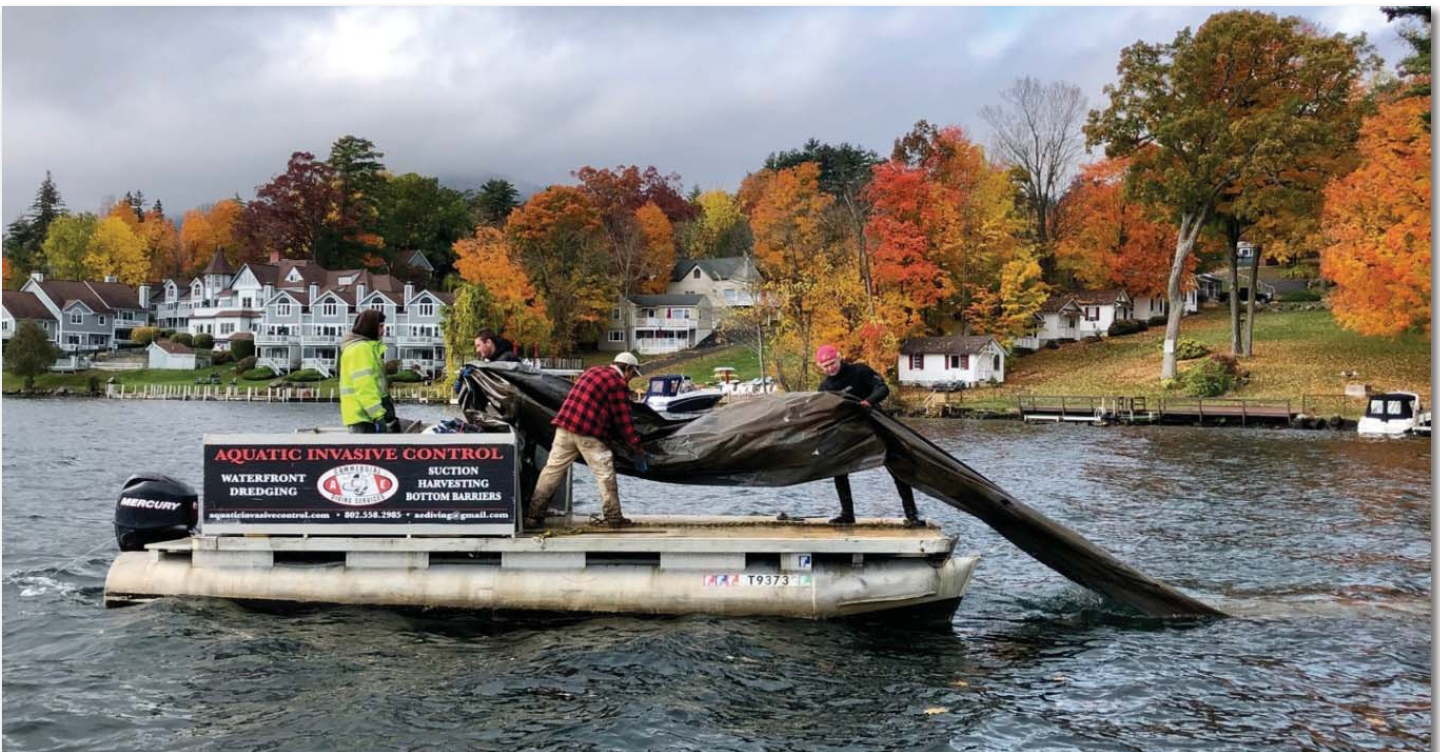
BELOW: The Lake George Park Commission and Lake George Association also collaborated to have AECDS remove Lake George Village 'Legacy Milfoil Mats', (also called bottom barriers, after almost 20 years of usage.

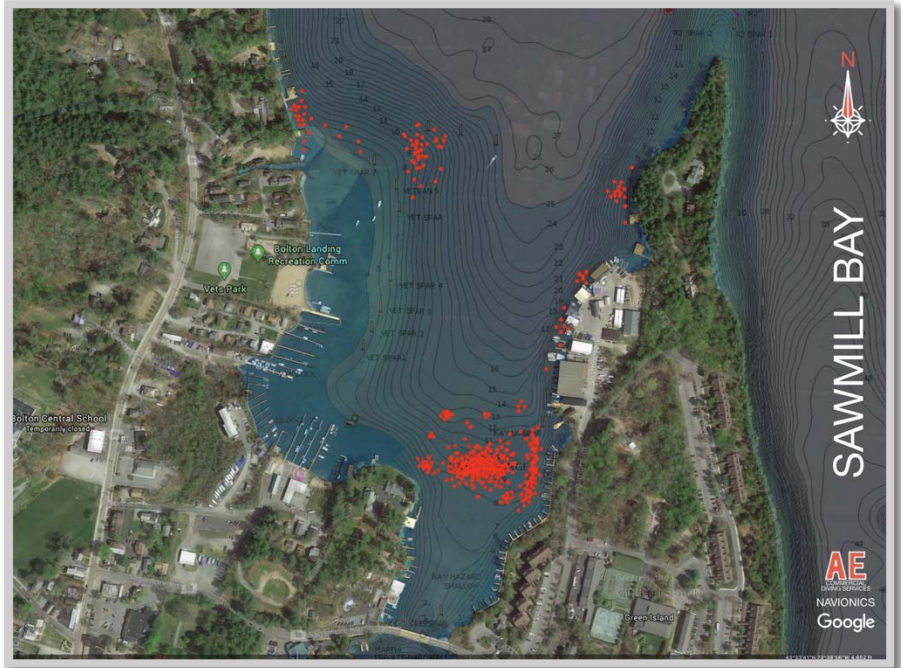
MAP 1 For Sawmill Bay, Green Island DEC, and Finkle Brooke Delta

This area of Sawmill Bay has not been worked in the recent past. It is located between the Green Island bridge and the DEC facility on Green Island. We started with one DASH crew and quickly realized that another DASH crew would be needed to complete the area in a timely manner. The bottom composition consisted of soft sediment near Green Island, muddy sand further from shore, with woody debris and decaying plant matter scattered throughout.

There was a mild inconsistent current present that tended to swirl in the bay and the depth of work was 8 – 12 feet. The overall area was approximately 4 acres in size with very large dense beds of Eurasian Milfoil surrounded by moderate to sporadic plants. This area had some of the densest EWM beds worked in 2020. The current made visibility challenging at times and the boat traffic is always a concern but overall, the area was not difficult to work. The close proximity to the dump site at the DEC and the Norowal Marina certainly helped also.

This area has a large amount of boat dockage and therefore it has a good deal of local boat traffic as well as pass through boat traffic. Due to these factors, we feel that it is important to be vigilant in this area. Any beds of Eurasian Milfoil left unchecked will become fragmented and allowed to become larger and spread north up the west shoreline of Green Island.

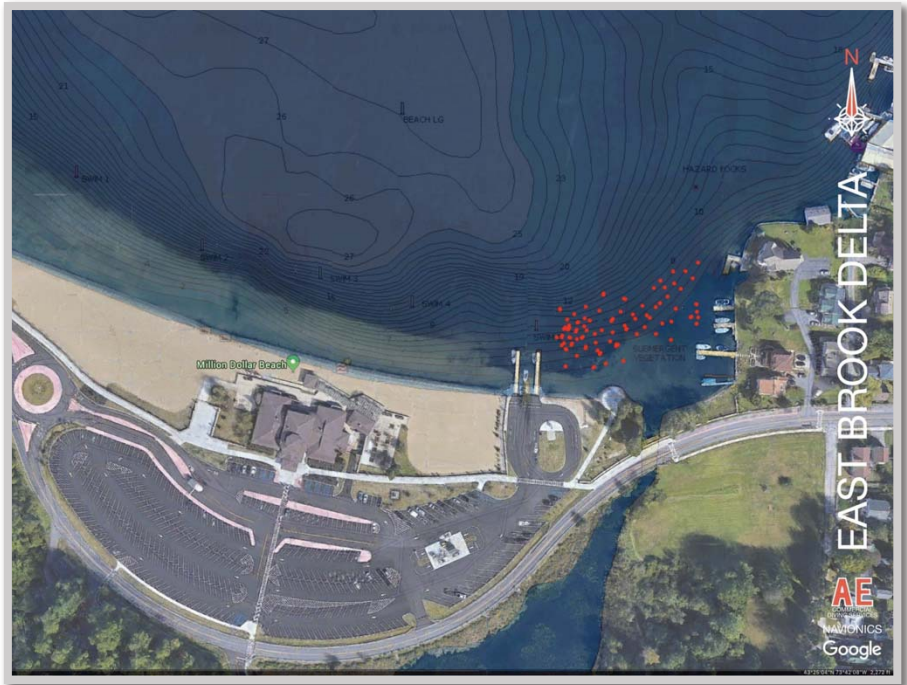
This area was completely harvested in 2019 and again in 2020. This site harbored a large dense patch of EWM in 2019 that started due east of the boat launch and extended northward up the shoreline. After the 2019 season, we hoped to see a reduction in EWM growth, and in fact saw that in 2020. The was quickly cleaned up. We We made a second visit to the site at the end of the season to clean up any regrowth.

We recommend surveying and working this site early in the season due to its' proximity to a very busy boat launch. Any EWM plants not removed can become fragmented very easily and allowed to spread.

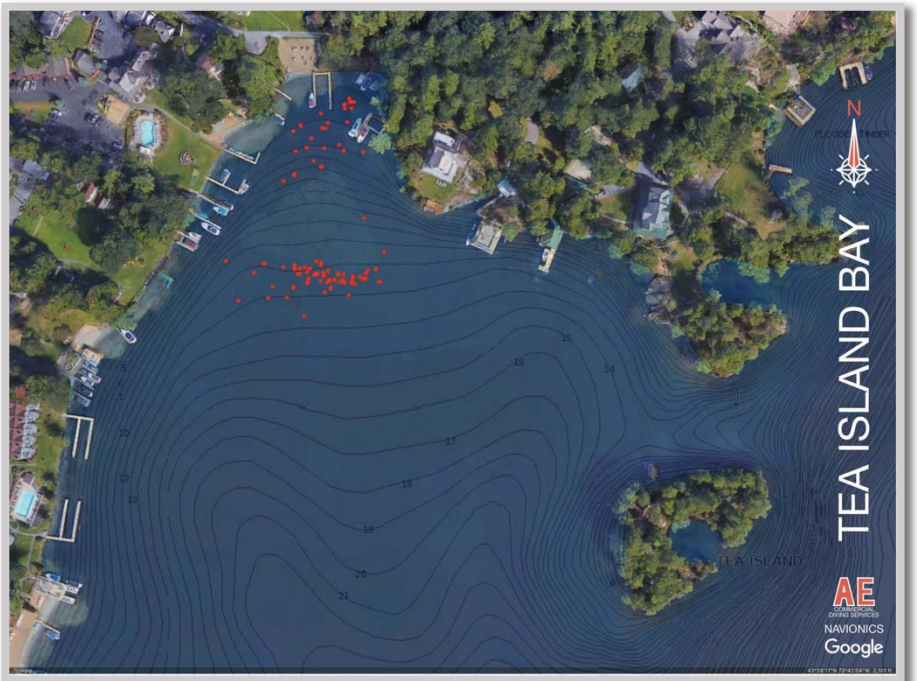
This site was completely harvested in 2018, 2019, and again in 2020. This season the EWM seems to grow primarily in the shallow corner of the bay that is also dense with native plants. Large dense beds of native plants are obviously very beneficial in our efforts to keep EWM out but require a more selective suction harvesting technique to ensure only the EWM is removed. Although necessary, this technique is more time consuming and effects productivity; native bycatch is inevitable. Eurasian Milfoil was also observed under the deeper edge of the benthic bottom barriers and was removed.

We recommend that close attention be paid to the trend of regrowth at this site in order to prevent a relapse into a denser area of infestation especially in the shallow areas and the areas of dense native growth.
