Lake George Integrated Aquatic Plant Management Program

Lake George Park Commission

Prepared by: Lycott Environmental Inc. Southbridge MA, USA
December 2008

EURASIAN WATERMILFOIL MANAGEMENT IN LAKE GEORGE 2008 PROGRAM REPORT

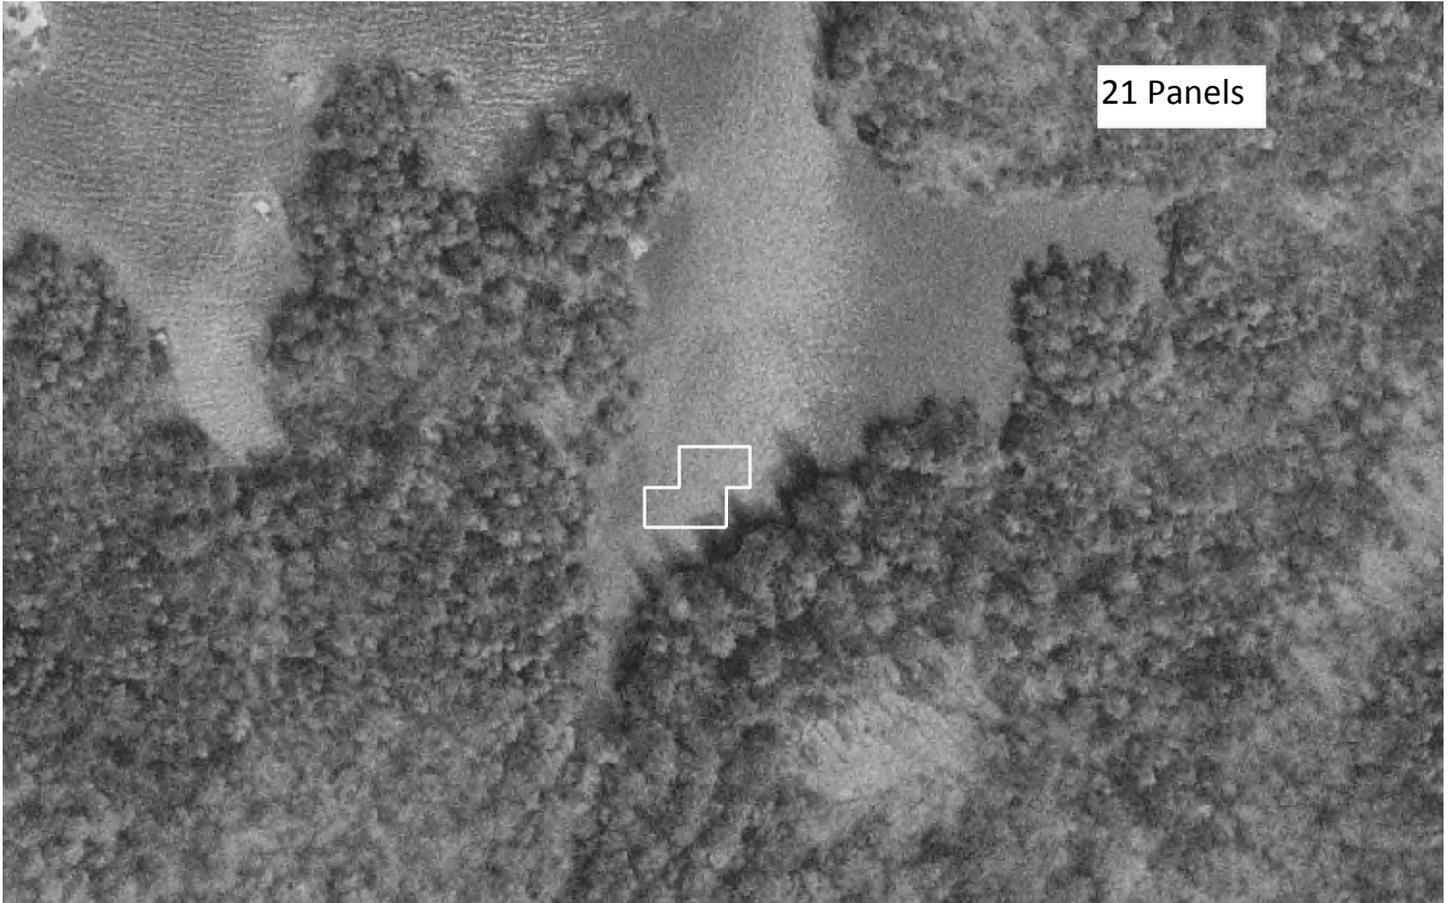
2008 Benthic Barrier Coverage Paradise Bay (M-41) Lake George Queensbury, NY

Paradise Bay (M-41). There was a moderate-sized area of low-density scattered plants in the northern arm of the bay. Eurasian watermilfoil was found at depths of from 1 to 4 meters. The native plant community appears disturbed. This area receives heavy boat traffic. Slope is moderately flat, with a silty substrate. Eurasian watermilfoil was removed from this site as part of the 1989 and 1990 hand harvesting project. Hand harvesting continued at this site until 1992. Since 1993, no maintenance has occurred and growth of milfoil has grown to large areas of heavy to moderate bed growth on the southeast shore. Moderate to scattered density of plants on the southwestern shore are also found within this enclosed bay. In 2008, 21 panels were installed on the southernmost bed. Scattered plants remain around this bed and the northernmost bed in this bay remains unmanaged at this time.

21 Panels
