Lake George Park Commission

Lake George Integrated Aquatic Plant Management Program

Prepared by: Lycott Environmental Inc. Spencer MA, USA

Final Report Submitted: January 2014

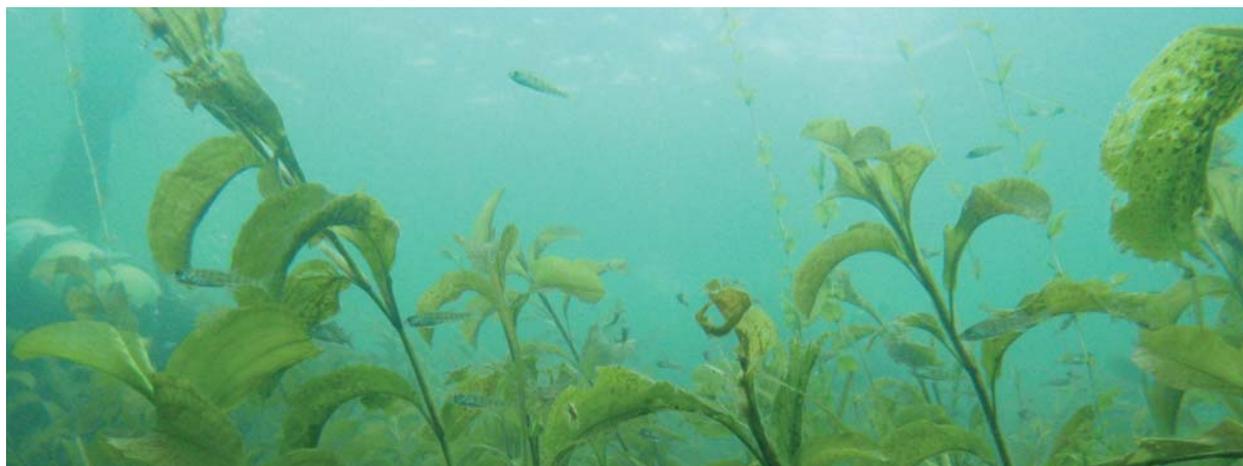
Site M71 3-years after removal of over 1-acre of benthic barrier. © Rich King 2013, Lycott Environmental Inc.

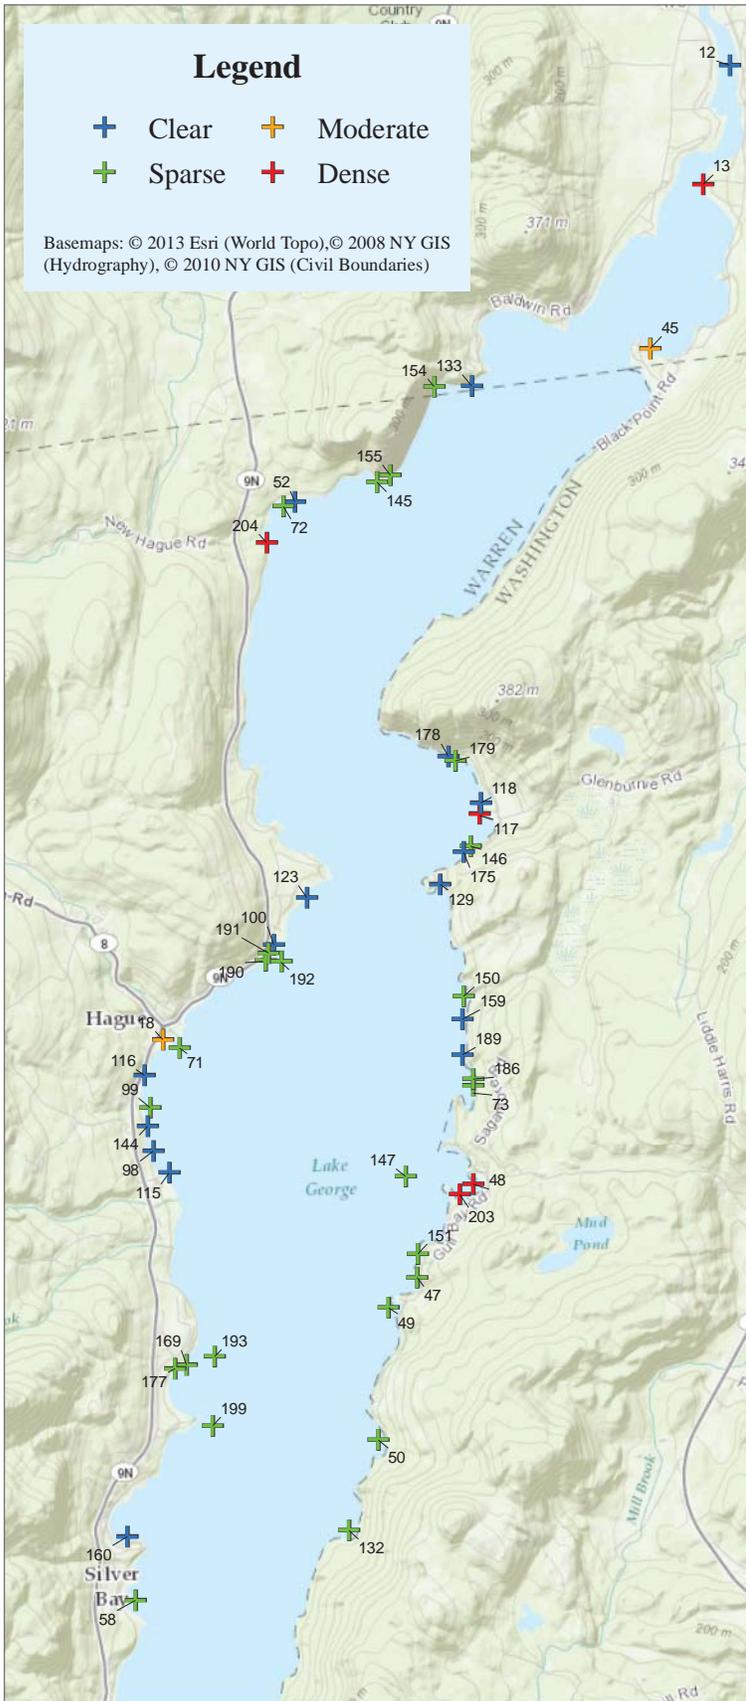
Pre-Management Site Status

Section A: 2013 *M. spicatum* Pre- and Post-Management Site Status

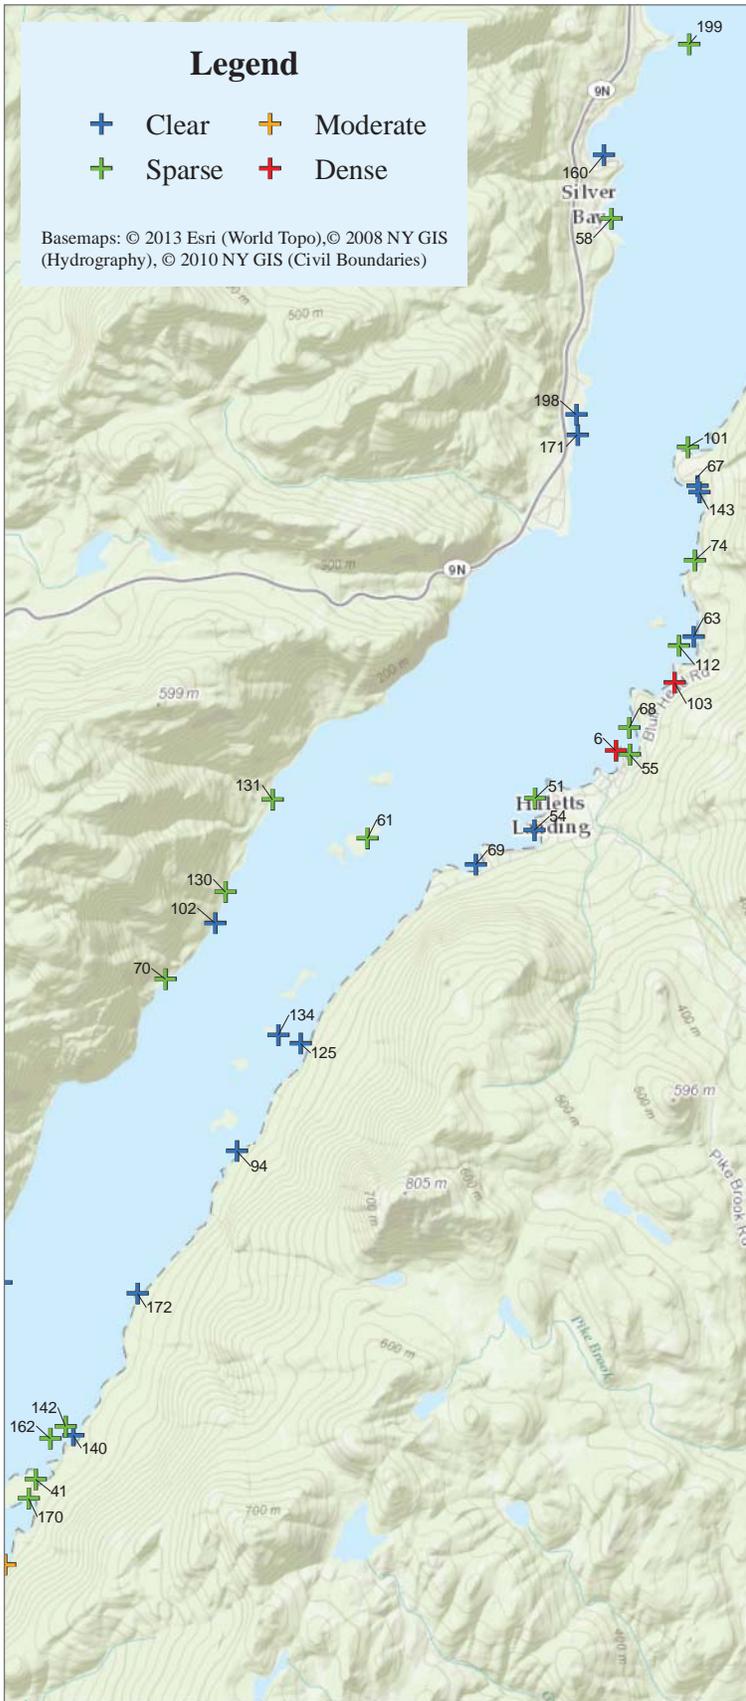
Pre-Management Site Status

Section B: 2013 *M. spicatum* Pre- and Post-Management Site Status

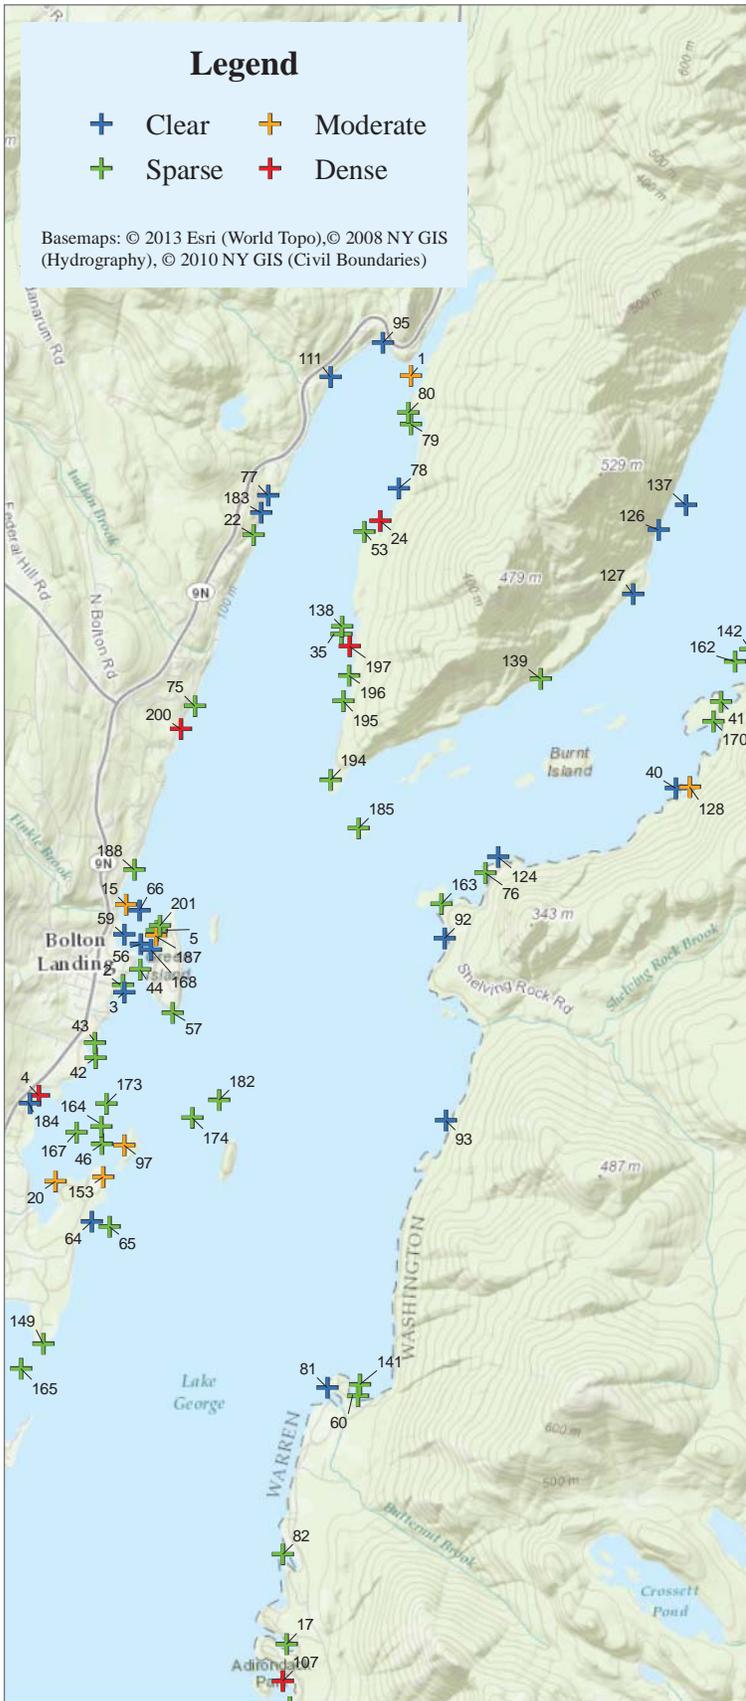
Pre-Management Site Status

Section C: 2013 *M. spicatum* Pre- and Post-Management Site Status

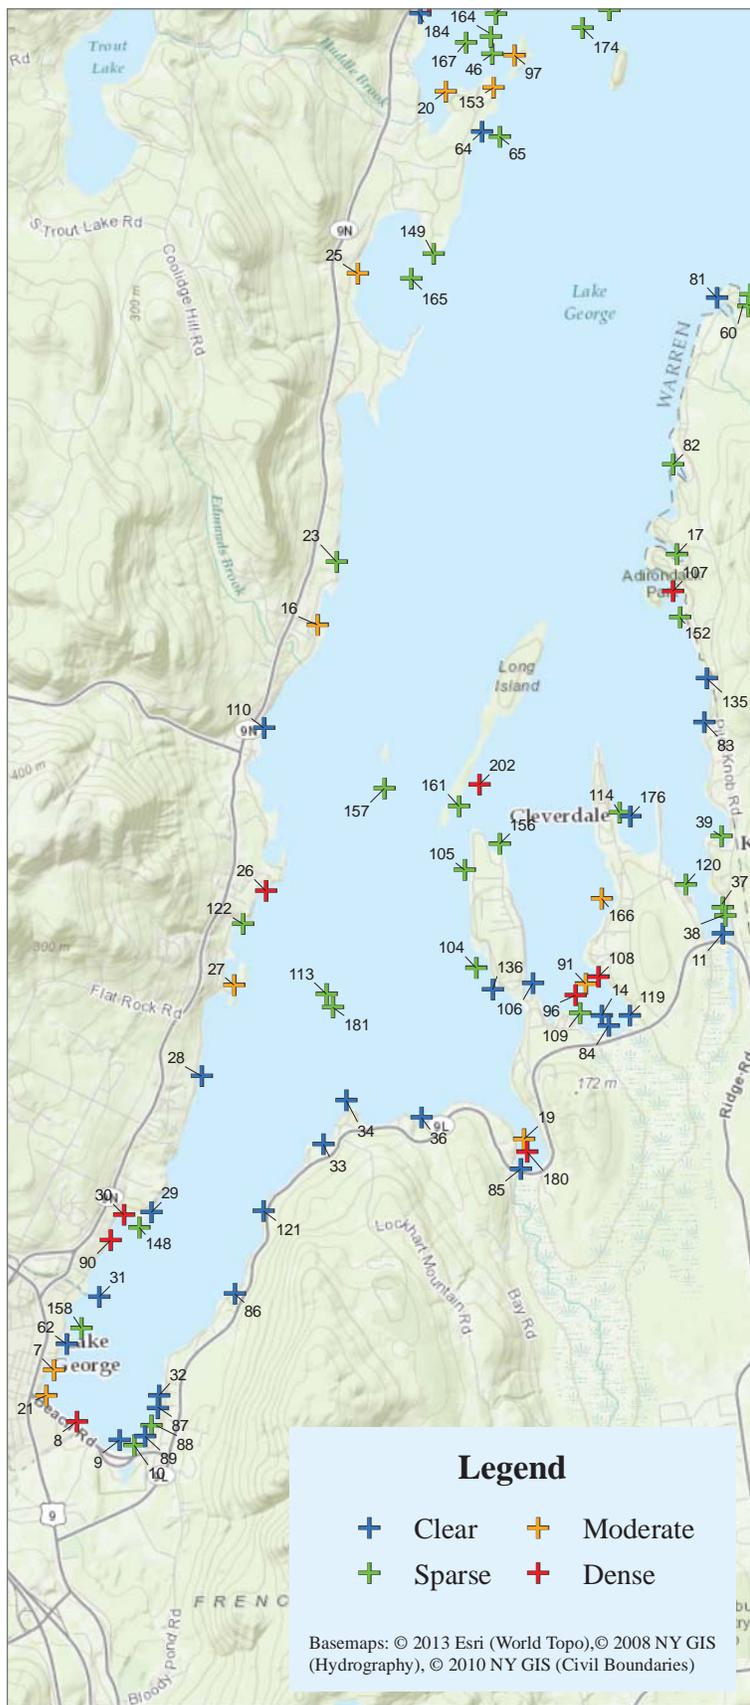
Pre-Management Site Status

Section D: 2013 *M. spicatum* Pre- and Post-Management Site Status
